# Manhole Inspection Summary

Manhole # S37I\_\_054MH

Insp Date: **11/19/08 10:22 AM**

**Location** Address: **400 e pratt st**

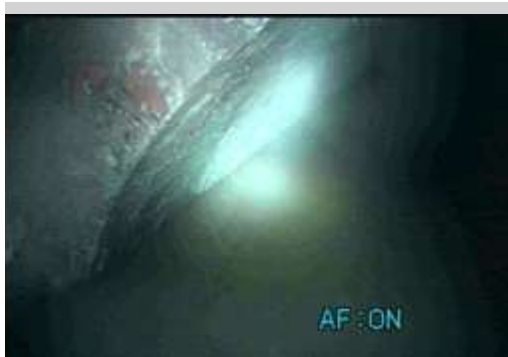
Pipe Out @ 12 OClock

left side of 74inch pipe

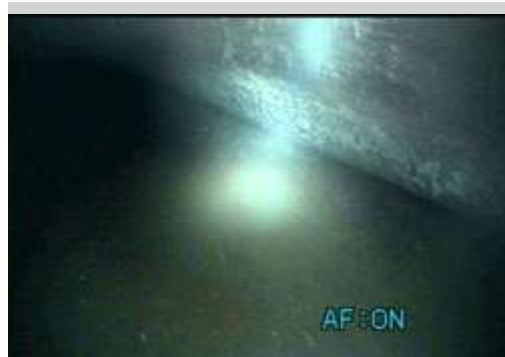
Pipe In @ 6 OClock

right side of pipe

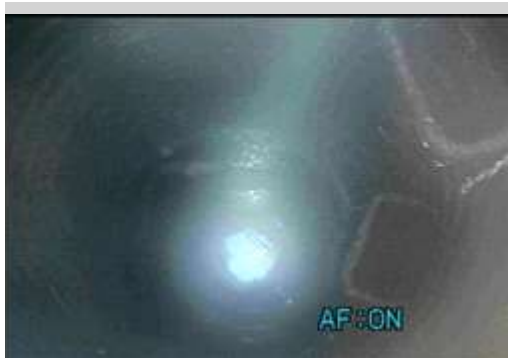
Defect 1

Count: **9** Missing: **1** ☒ **Corroded**

Corroded Steps

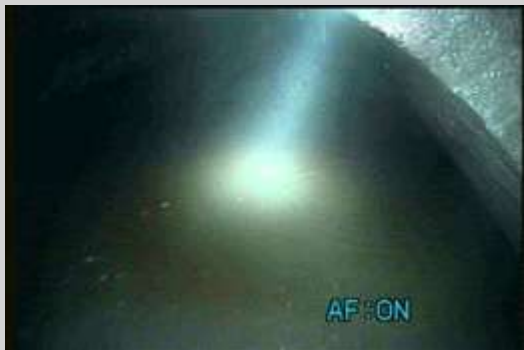
Pipe Out @ 12 O'Clock

right side of pipe

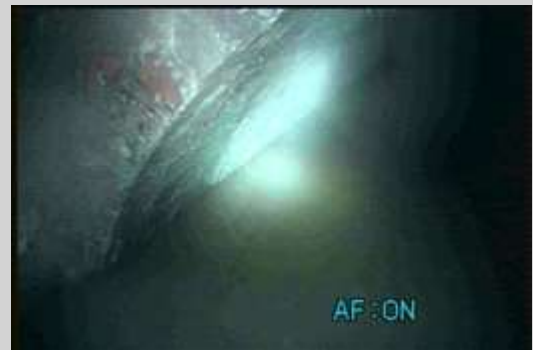
left side of 74inch pipe

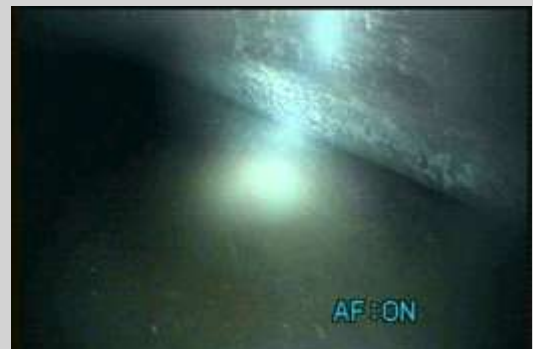
right side of pipe
